## STAR ONLINE PUBLICATION

**Case Number: S2123000009 Rev A**

**Symptom/Vehicle Issue: Water is leaking into cab through the third brake light CHMSL**

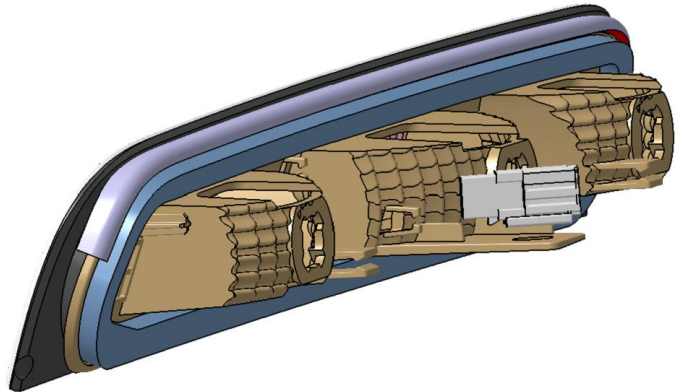
Apply the secondary gasket onto the plastic above the main gasket; the secondary gasket and main gasket will not touch. The secondary gasket should be at the top of the part when installed.

Check: once the CHMSL is installed onto the vehicle there should be no gasket visible from the top or the sides.

Order a replacement Incandescent Bulb CHMSL (Part Number 68298380AE) and a secondary gasket (Part Number 68545973AA).

**Note:** part numbers 68298380AF and 68298380AG will already have the secondary gasket applied and you won't have to order the part separately.
